**Subject: Field Oversight Summary No. 1
Final Remedial Design Activities
Blackwell Forest Preserve Landfill, DuPage County, Illinois
Contract No. 68-W8-0084, Work Assignment No. 84-5P6Y**

**FIELD OVERSIGHT SUMMARY NO. 1
FINAL REMEDIAL DESIGN ACTIVITIES
BLACKWELL FOREST PRESERVE LANDFILL
DUPAGE COUNTY, ILLINOIS**

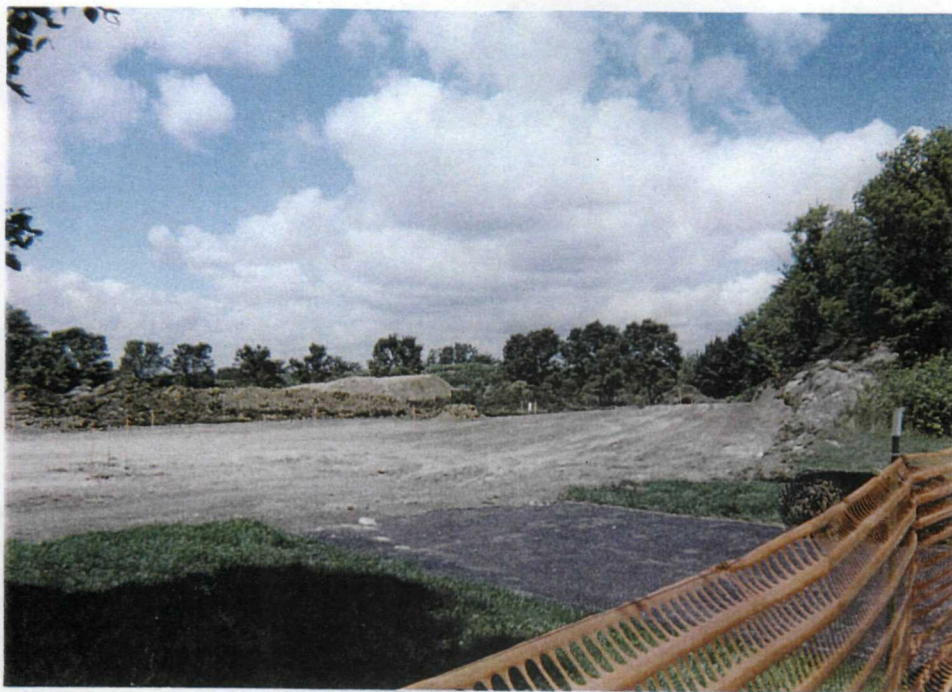
Photograph No. 1
 Orientation: North
 Description: Excavation of original cap at Area 3

1335 Photo 1 (N) - excavated area of Area 3

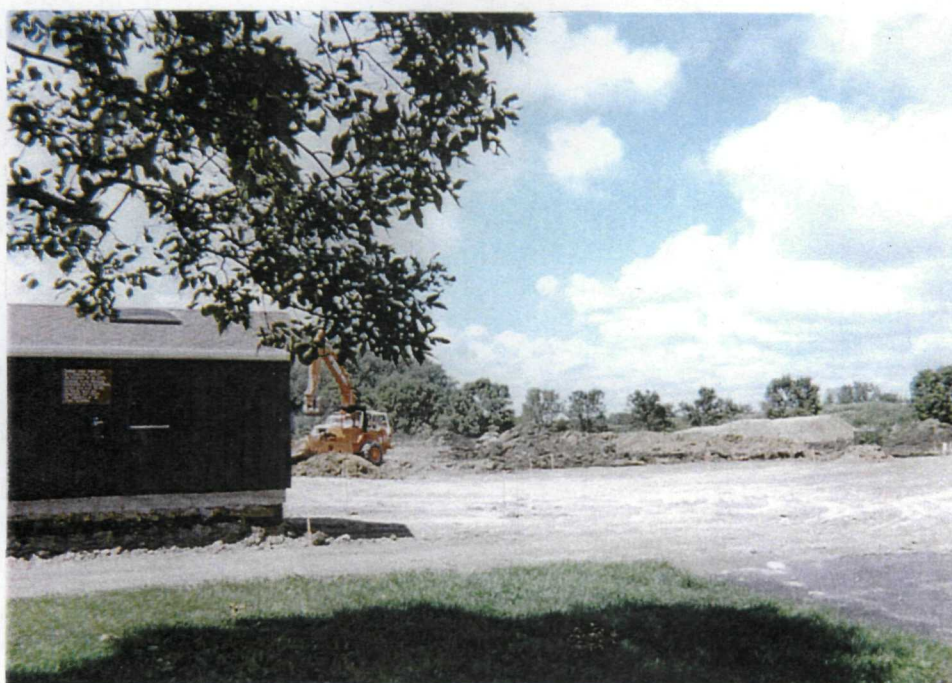
Photograph No. 2
 Orientation: Northwest
 Description: Excavation of original cap at Area 3

1336 Photo 2 (NW) - Est current excavation in Area 3

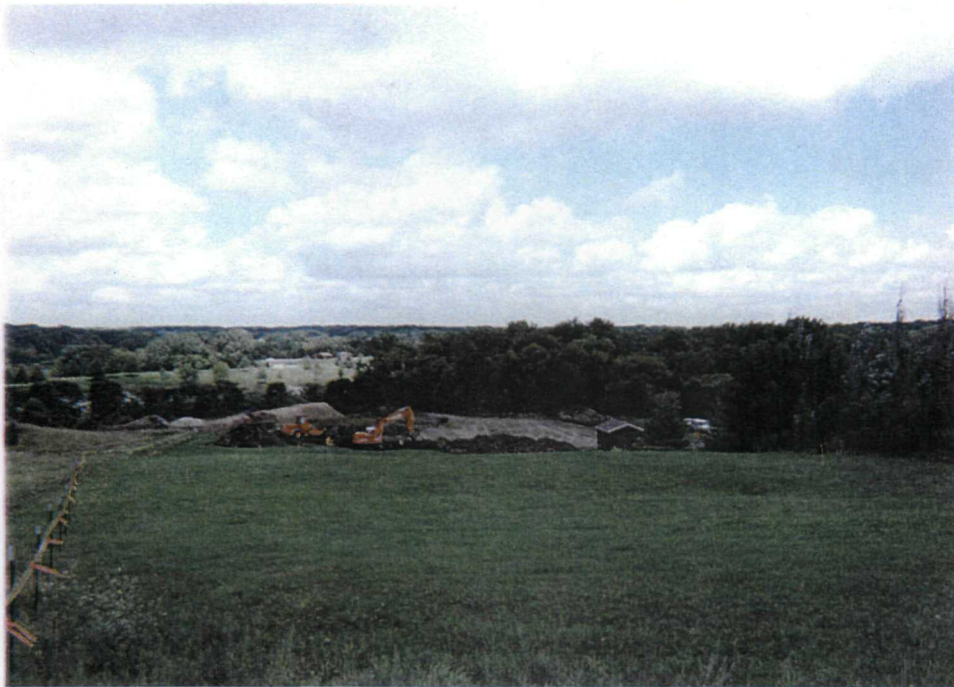
Photograph No. 3

Description: Overview of Area 3 during excavation of original cap

1345 Photo 3 (NW) - section of Area 3⁴ capped w/ material excavated from Area 3. Material consists mainly of clay. Steep slope to left (S) of photo

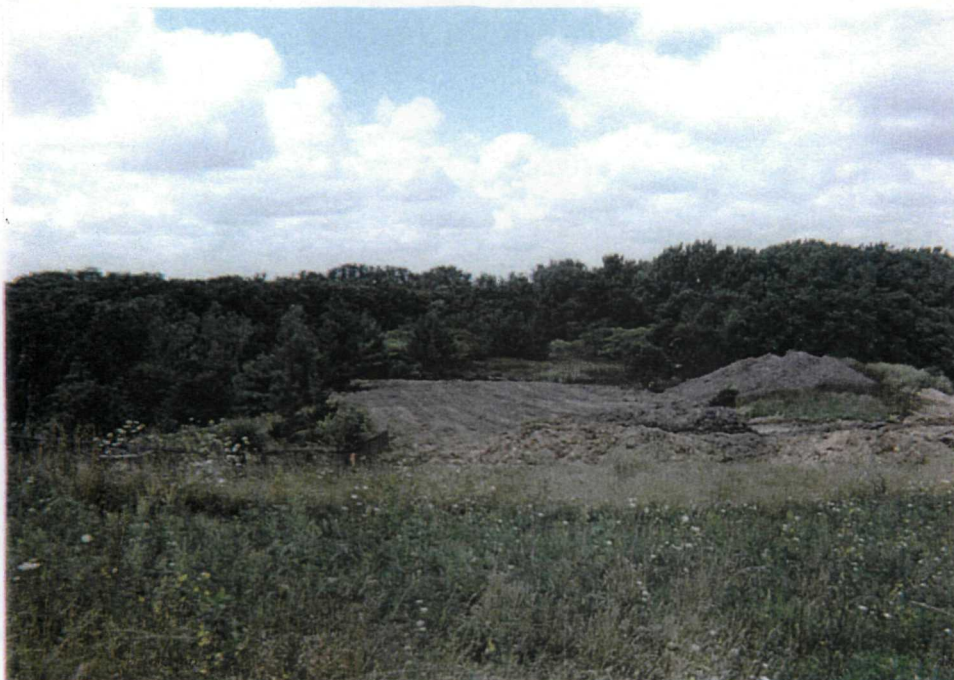
Photograph No. 4

Description: Portion of Area 4 used to store material excavated from Area 3; material has been contoured for surface water drainage

1345 Photo 4 (W) - Overview of Area 3 excavation

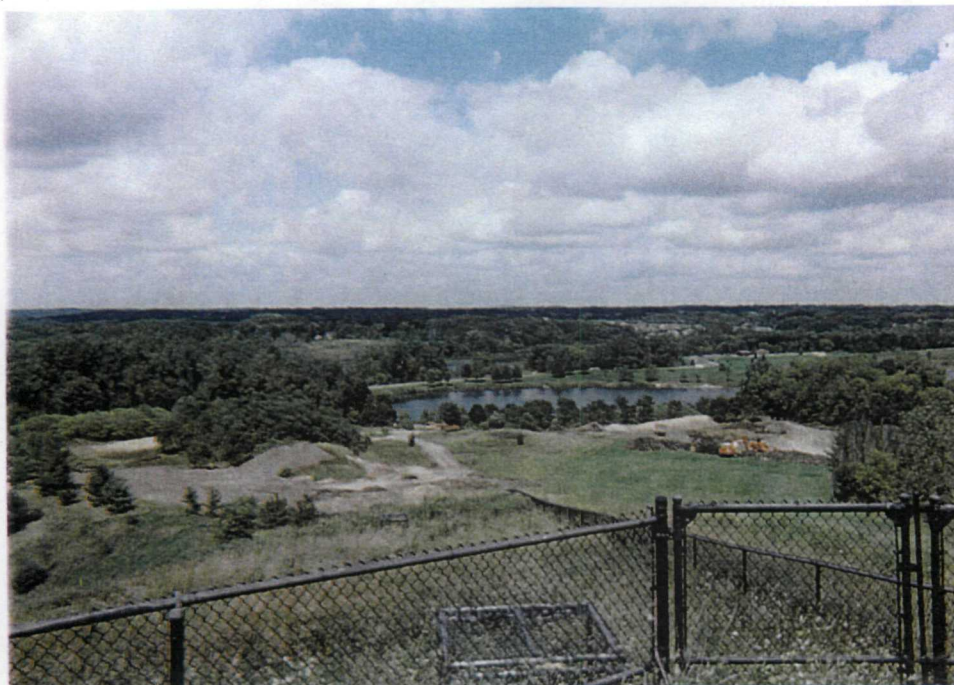
Photograph No. 5

Description: Overview of excavation of Area 3 (right) and Area 4 (left)

1355 Photo 5 (N) - Overview of Area 3 excavation + Area 4⁴ capping. Photo taken from the top of the landfill

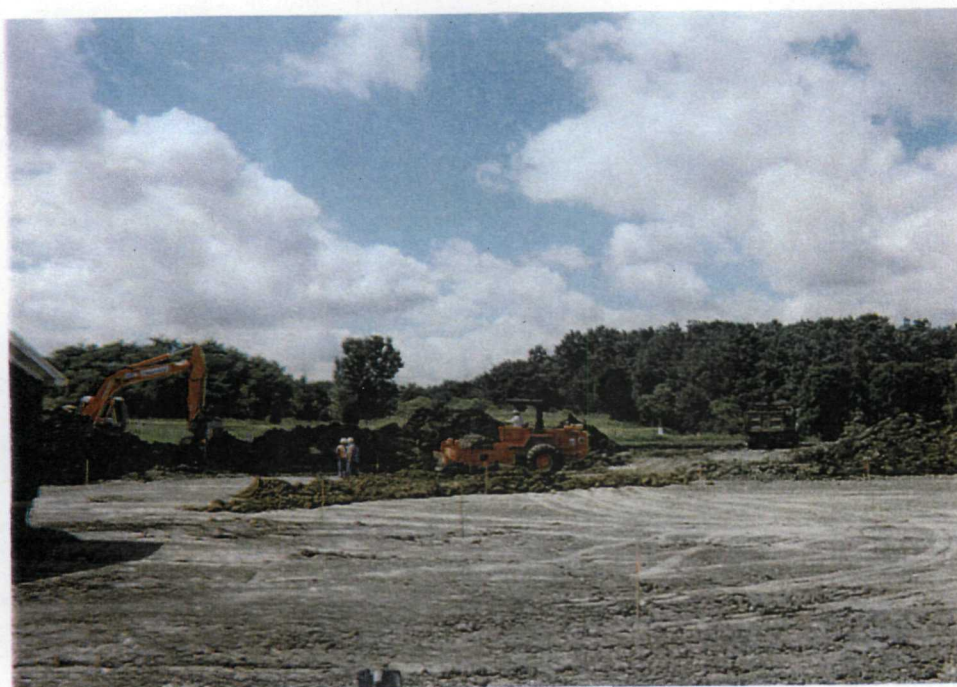
Photograph No. 6

Description: Capping of Area 3

1405 Photo 6 (W) - Capping of Area 3 excavated to the left removing topsoil

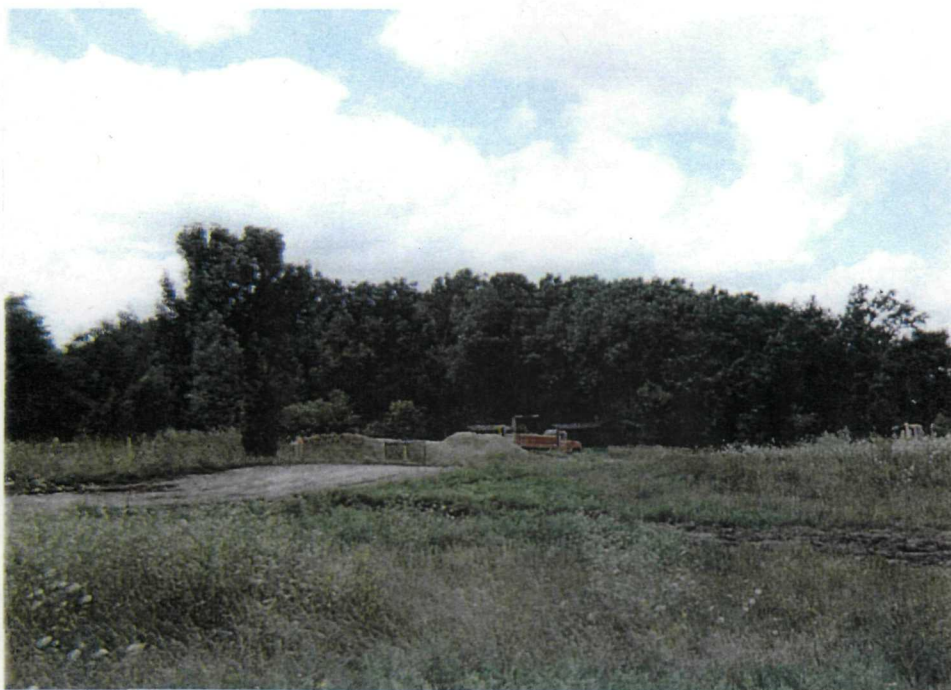
Photograph No. 7

Description: Loading of soil stockpiled west of Area 3 for use in recapping Area 3

1410 Photo 7 (W) - Loading of stockpiled soil located west of Area 3.
Soil used to cap Area 3

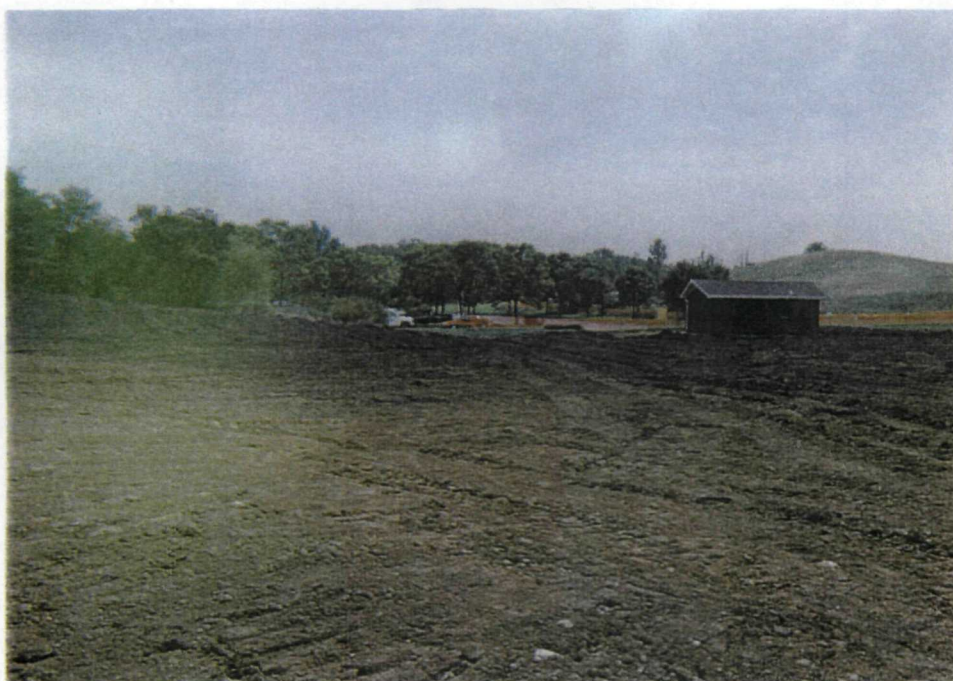
Photograph No. 8

Description: Area 3 after installation of new cap

1140 Photo 8 (E) - Area 3 after it has been capped.

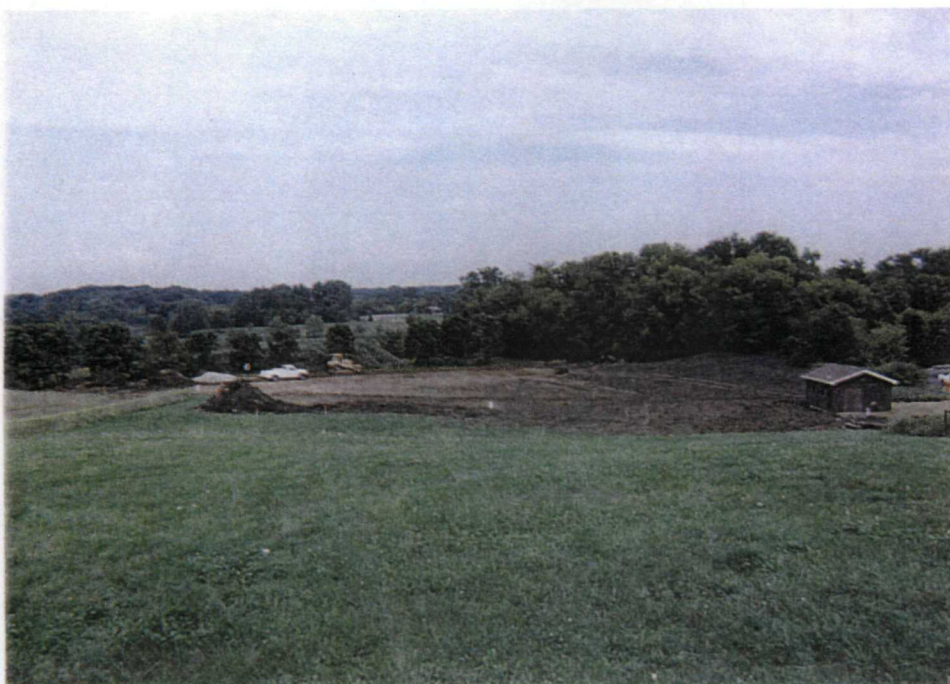
Photograph No. 9
 Orientation: North
 Description: Spreading of topsoil over Area 3 cap

1130 Photo 9 (N) - Area 3 after capping. Topsoil being spread in area. Area has been sloped for drainage. Light colored area is mound of soil that was knocked down to form berm on high area. Water will flow to west (left) & east (right).

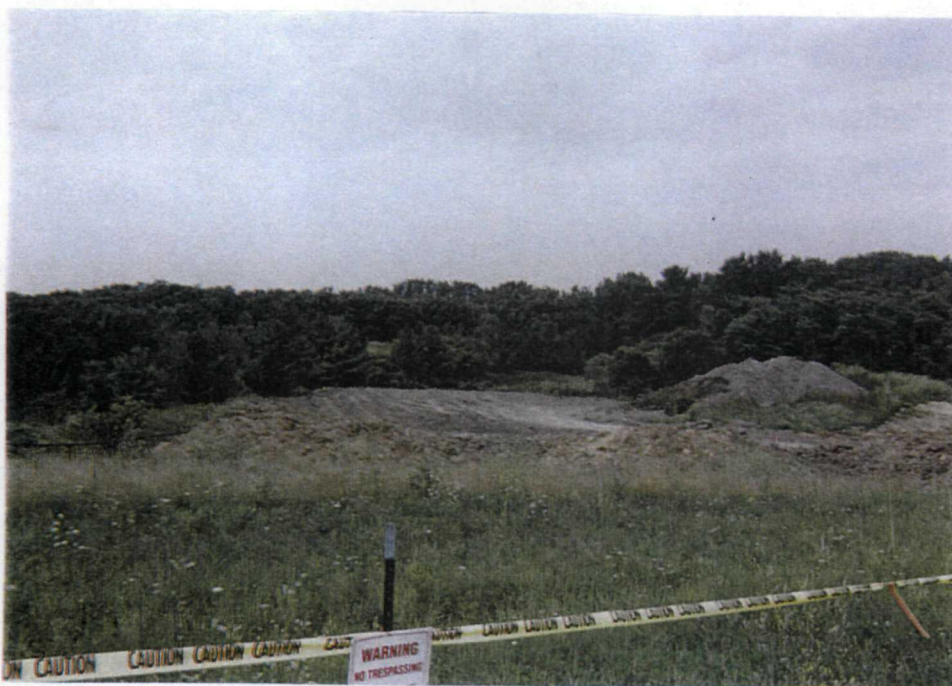
Photograph No. 10
 Orientation: West
 Description: Excavated material stored in Area 4 after it had been regraded and contoured to promote surface water runoff

1335 Photo 10(w). Area 4 → appear
to be the same as last week.

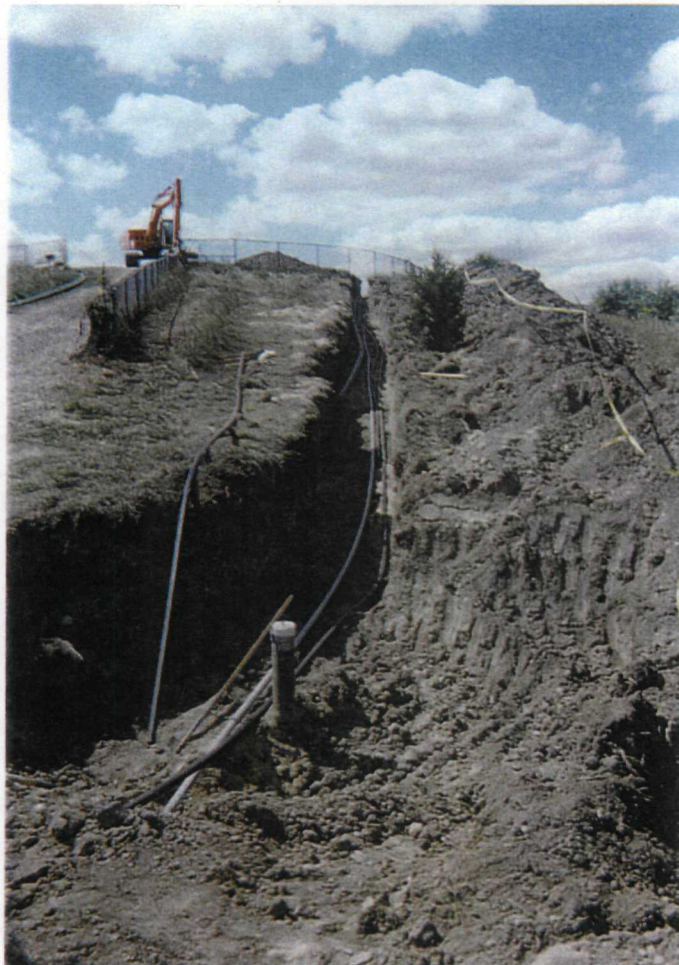
Photograph No. 13

Description: Polyvinyl chloride pipes placed in leachate conveyance trench; three smaller pipes were 2 inches in diameter and were for electrical lines, leachate conveyance, and compressed air; large pipe was 6 inches in diameter and was for landfill gas conveyance

1330 Photo 13 (W) - View of leachate conveyance line from EW 05. 4 pipes installed are evident

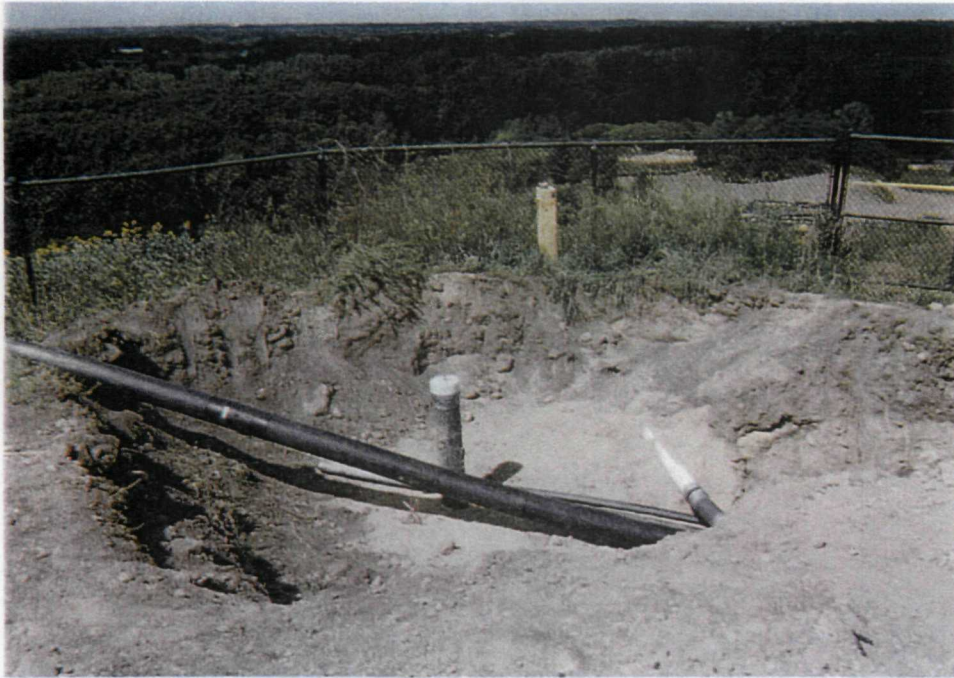
Photograph No. 14

Description: View of EW-04; pipes from leachate conveyance trench also visible; pipes had not yet been connected to the well

Photo 14 (W) - Extraction well EW-04. Pipes in trench have not yet been hooked up to well head.

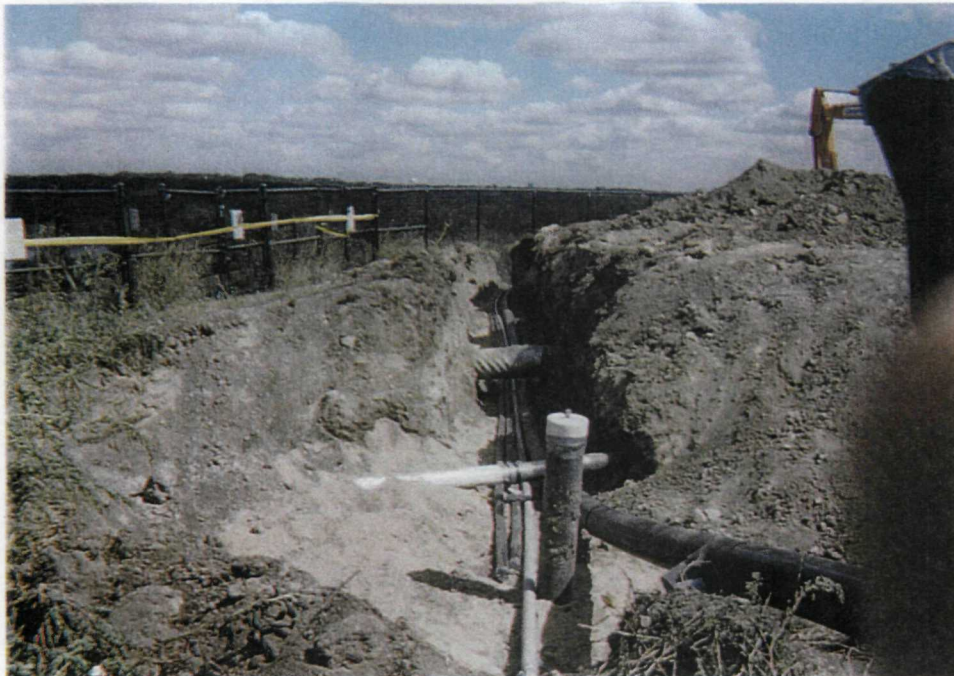
Photograph No. 15

Description: View of leachate conveyance trench from EW-04

Photo 15 (E) - View of leachate conveyance line from EW 04

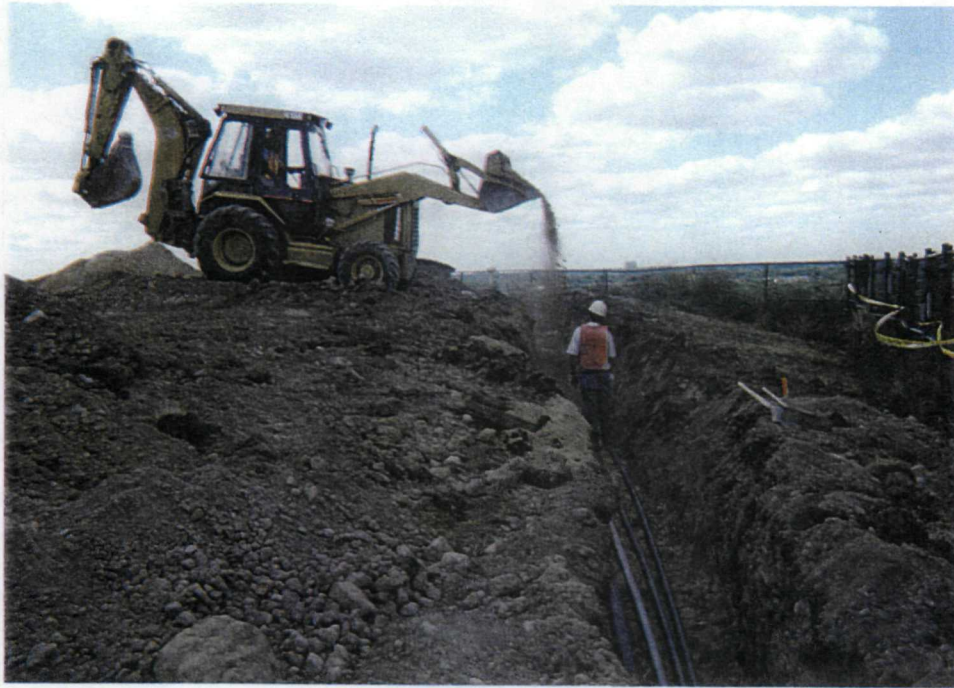
Photograph No. 16

Description: Sand backfill being placed over pipes in leachate conveyance trench

Photo 16 (W) - RTL placing backfill in trench by EW 04

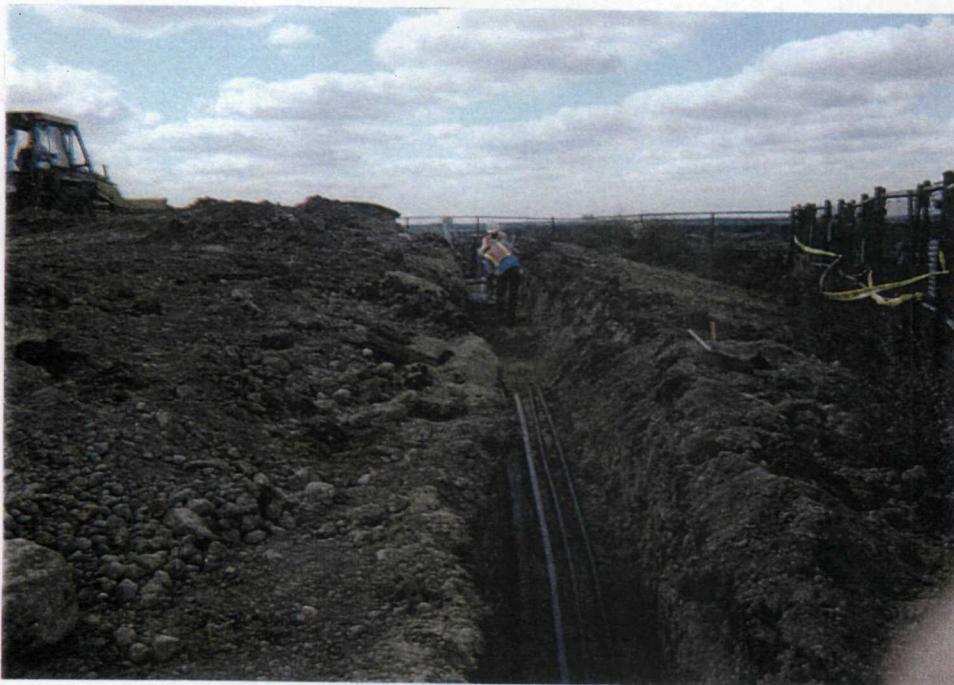
Photograph No. 17

Description: Sand backfill being placed over pipes in leachate conveyance trench

Photo 17 (W) - RTL spreading sand over pipes in trench

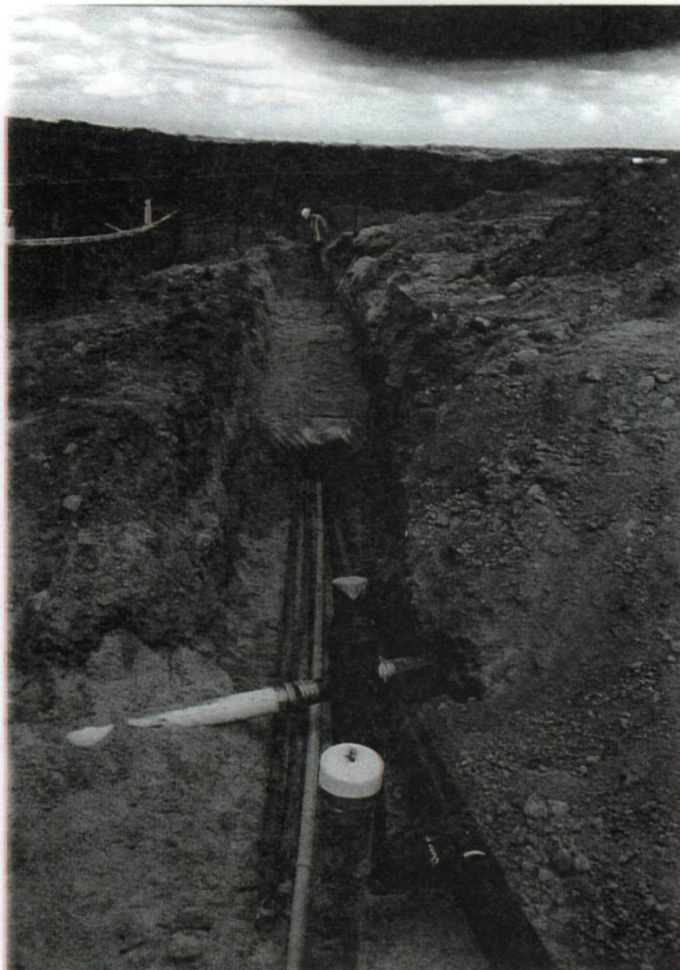
Photograph No. 18

Description: Sand backfill being placed over pipes in leachate conveyance trench

Photo 18 (E) - Sand being spread in trench
